Manhole Inspection Summary

Manhole # S41AA_034MH

Insp Date: **8/7/08 9:43 AM**

Location Address: **800 n caroline st**

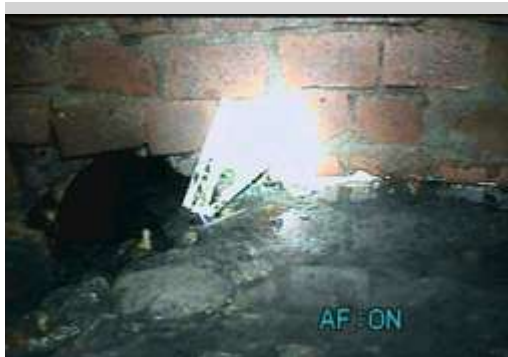
Defect 5

Condition: ☐ Sound ☐ Cracked ☐ Root Intrusion ☐ Deteriorated ☐ Leaks ☒ Debris

bench debris

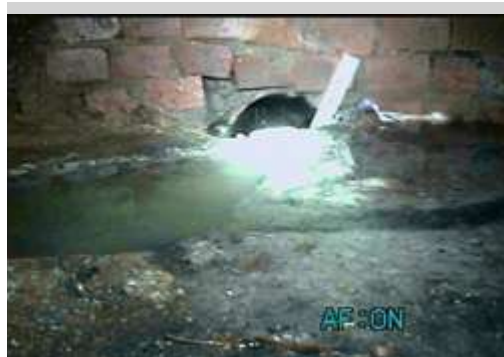
Defect 4

Condition: ☐ Sound ☐ Cracked ☐ Root Intrusion ☐ Deteriorated ☐ Leaks ☒ Debris

channel debris (full of water)

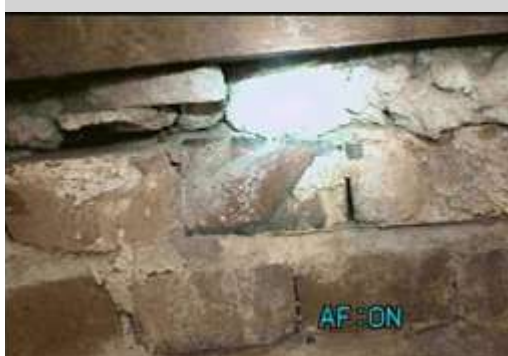
Defect 3

Condition: ☐ Sound ☐ Cracked ☐ Root Intrusion ☒ Loose Brick ☒ Deteriorated

loose bricks, deteriorated, frame adj

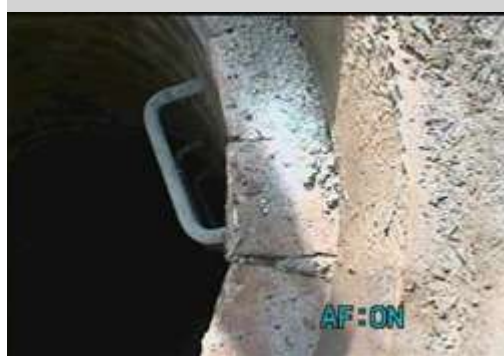
Defect 2

Offset: **3** (in.)

offset

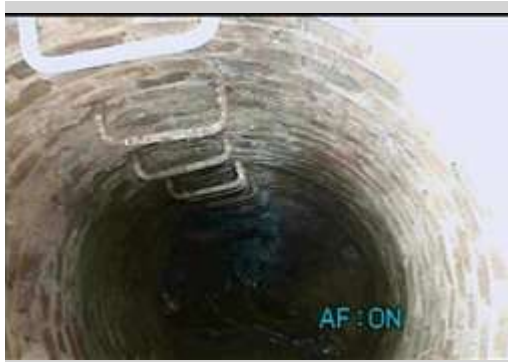
Defect 1

Count: **8** Missing: **0** ☒ Corroded

steps

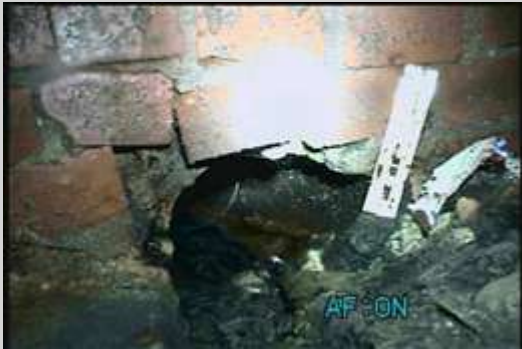
12 O'Clock Outflow

Deposits: ☐ None ☐ Mud ☐ Sludge ☒ **Debris** ☐ Grease

Silt Depth: 3 (in.) Deposits Extent: **Light**
